Conditions Assessment

Mt. Everett Academy

June 2014

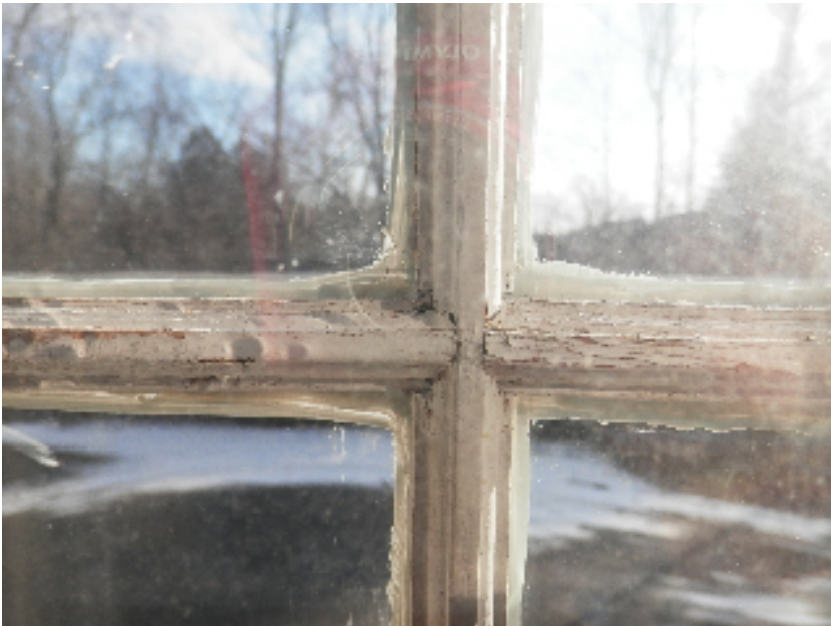
Image 3. Detail of the original sash. The ogee profile of the muntin bar is typical of the period of construction.

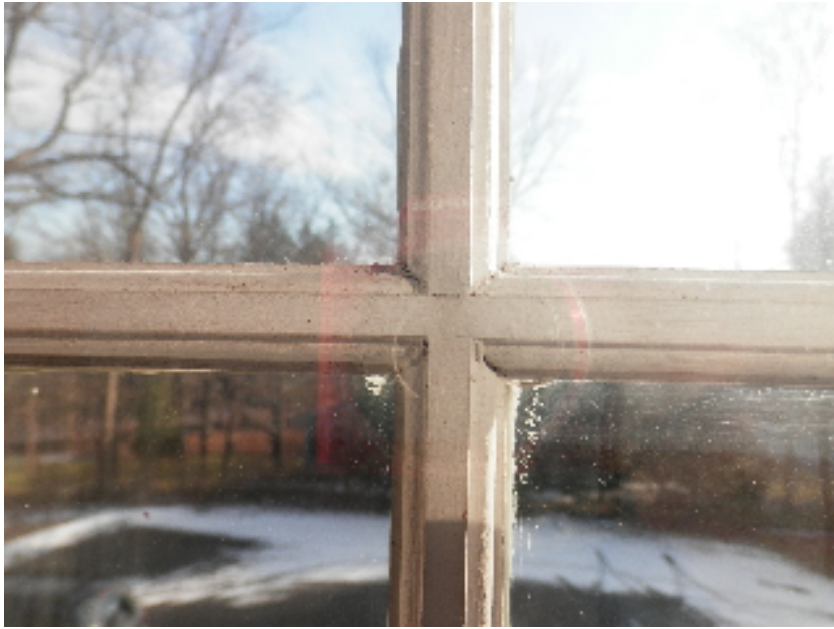
Image 4. Detail view of the replacement sash in the window openings that had 2/2 sash in the HABS photo.

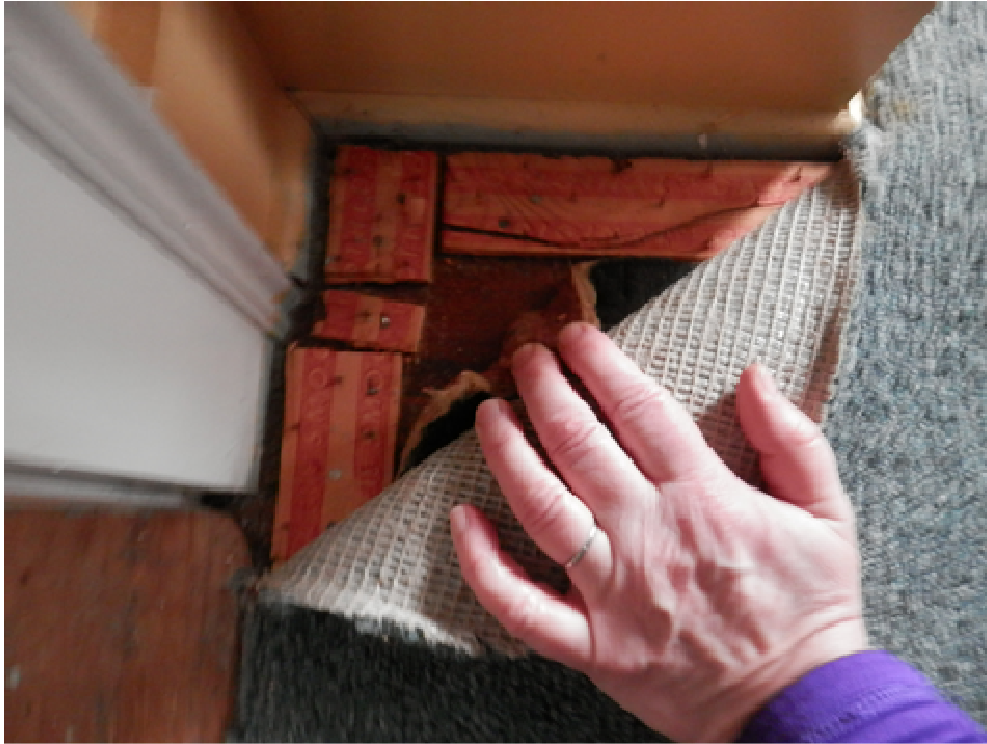
Image 6. Wall-to-wall carpeting covers much of the floor in the

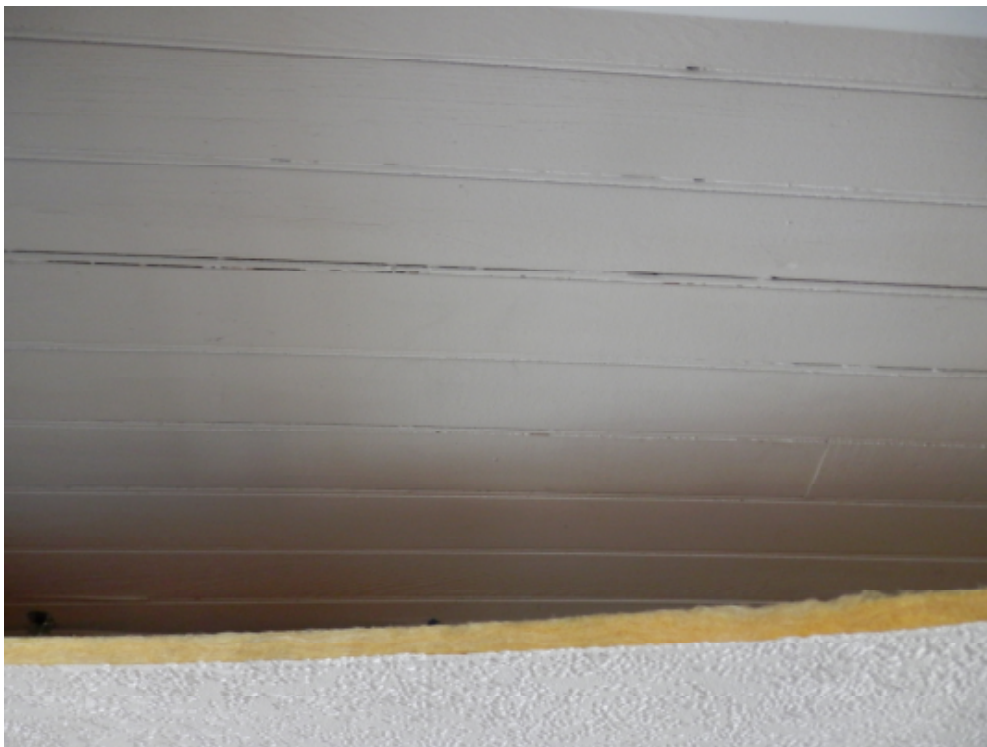
Image 7. An early, bead board ceiling finish is concealed by contemporary, false ceiling materials.

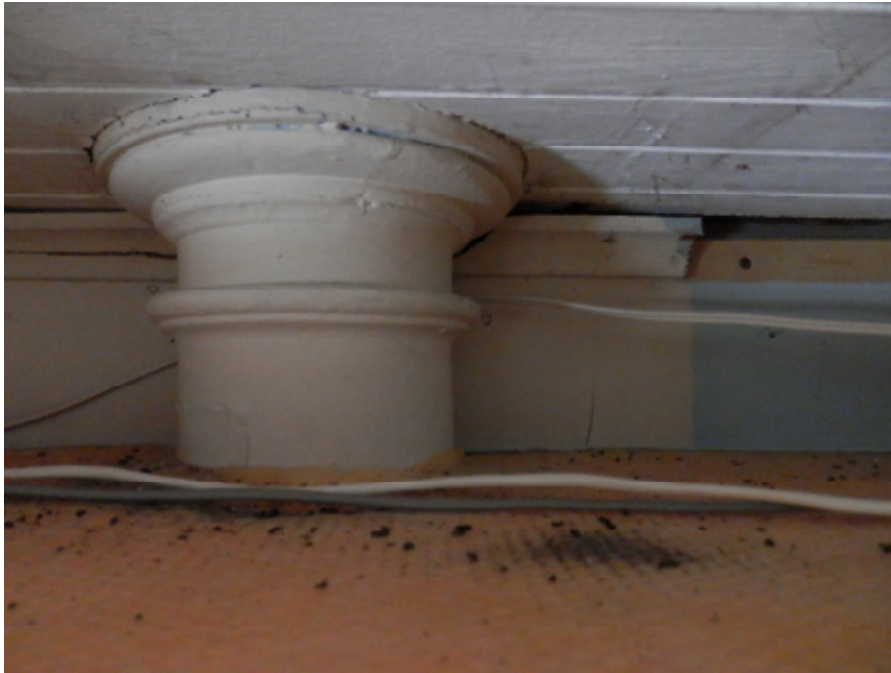
Image 8. In the library space, the column capital is concealed within the dropped ceiling space.

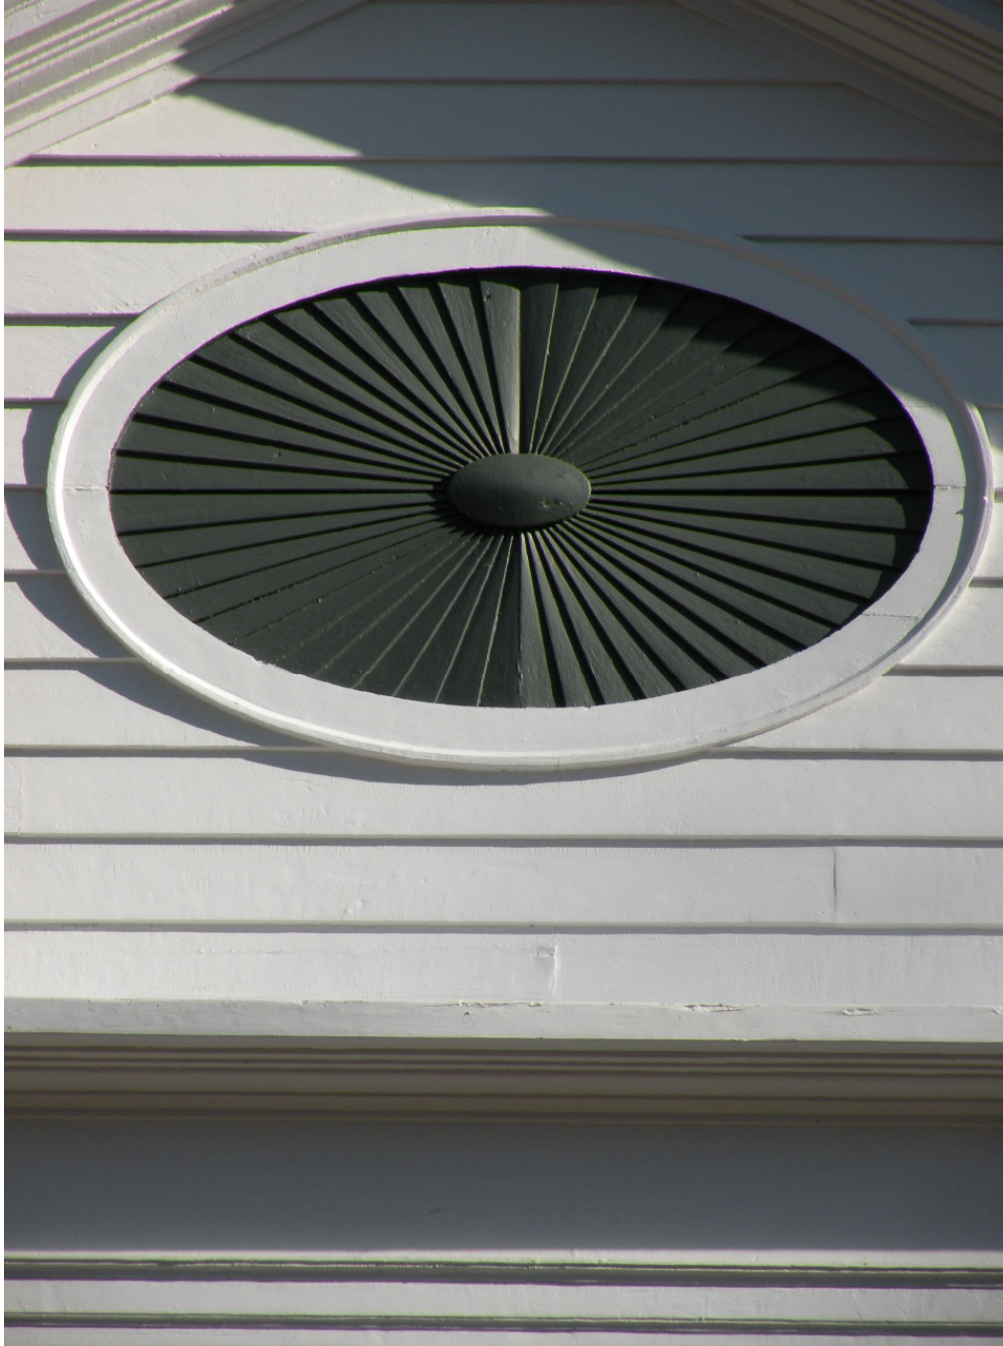
Image 15. There is a prominent elliptical attic fan ornament in the pediment painted deep green.

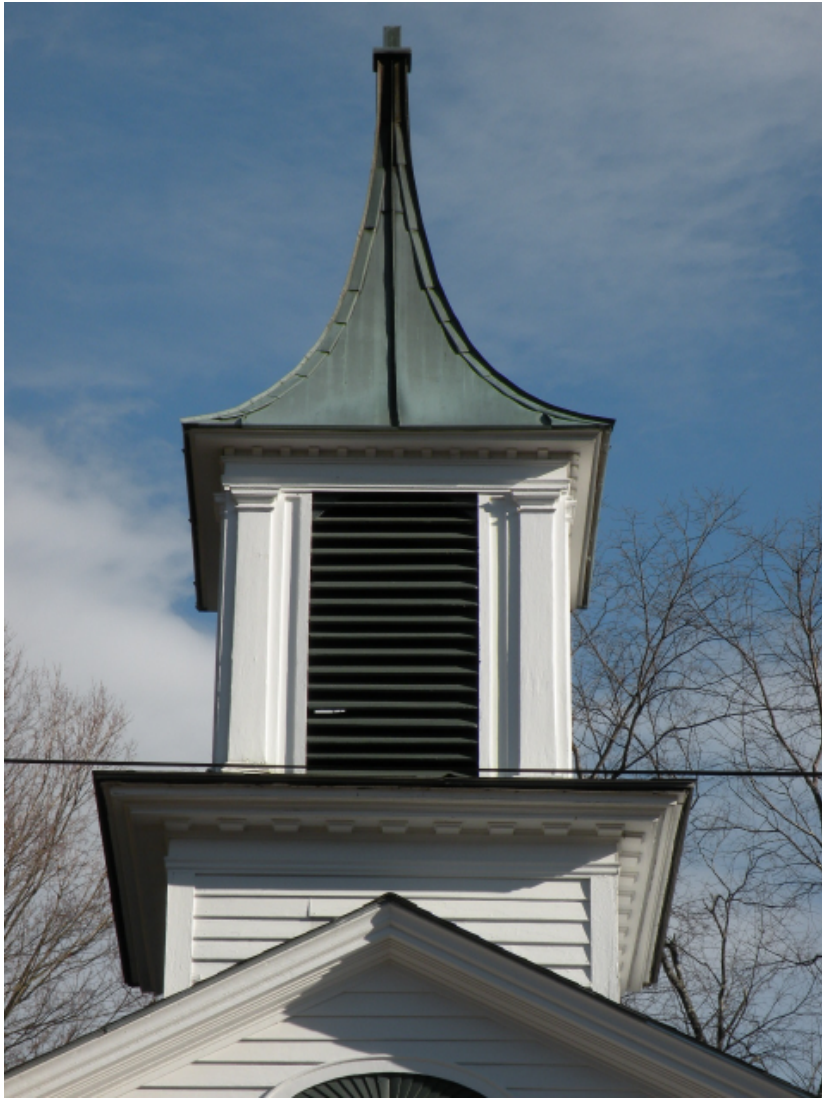
Image 16. The square bell tower has four identical sides. The base of the tower is painted clapboard with painted wood corner trim and entablature. The eave cornice has flat, painted modillions. The belfry has two engaged flat pilasters with recessed panels painted white that flank a wood-slat louver painted in a contrasting dark green. The pilasters support an entablature with shaped wood dentils at the cornice.

All aspects of the bell tower configuration and trim appear to be original with the possible exception of the copper material of the roof. The tower in its entirety is one of the most significant features of the building. Windows and the hand-blown glass should be retained and restored when required. The stone foundation and steps should be retained to the greatest extent possible.

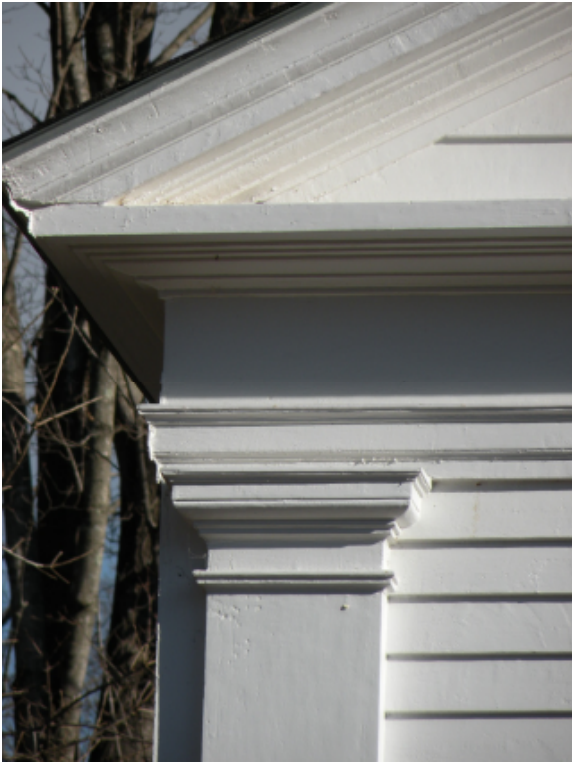
Image 17. The remaining Greek Revival moldings on the West Elevation and the tower appear to be original.

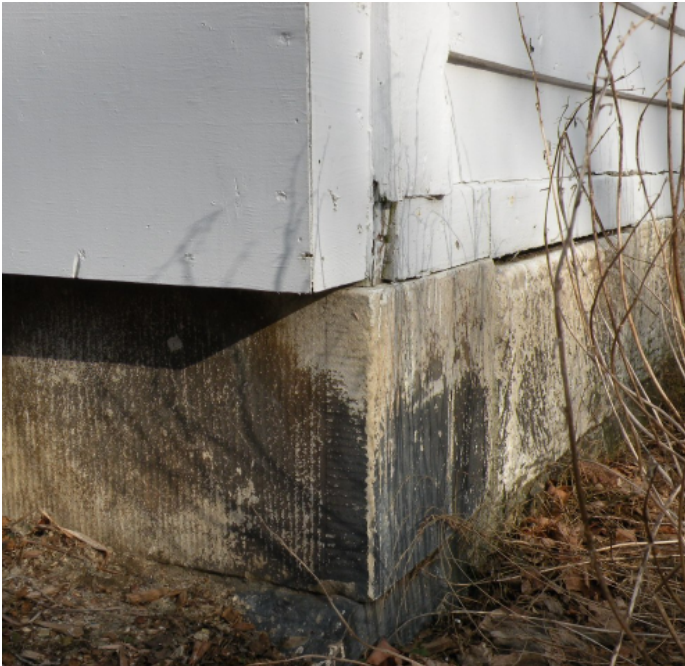
Image 19. The main building foundation is of locally quarried marble blocks with varying degrees of hand finishing.

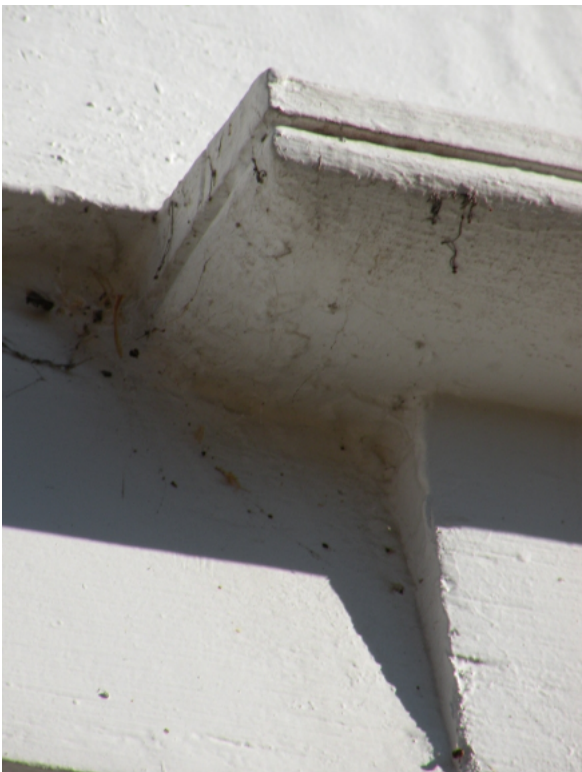
Image 20. The Greek Revival profiles of the drip molding over the windows are employed only on the main facade.

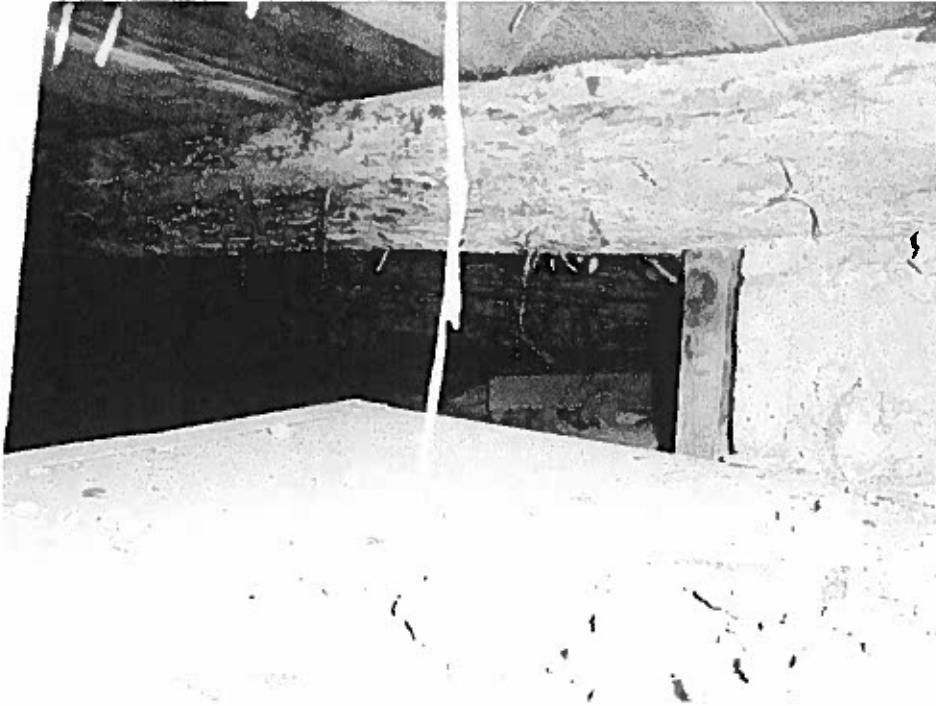
Looking northwest

Underside of flooring system at east end of building. Hand hewn floor joist, decking above. Note support at east end of joist.

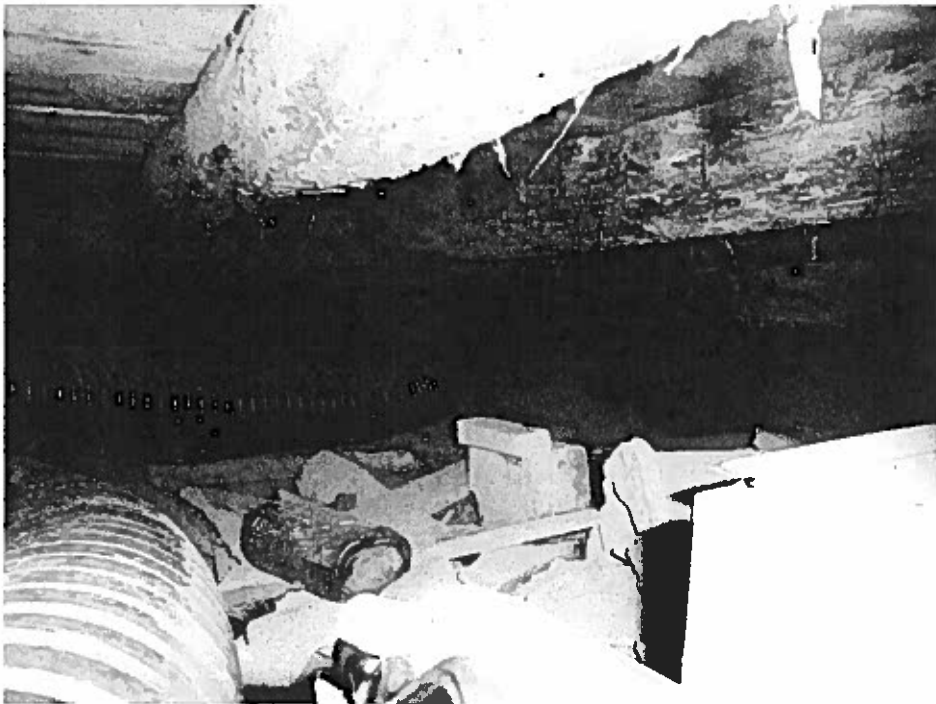
Looking west

Underside of flooring system at east end of building. Hand hewn floor joist supported by beam, decking above. Heating duct temporarily removed.

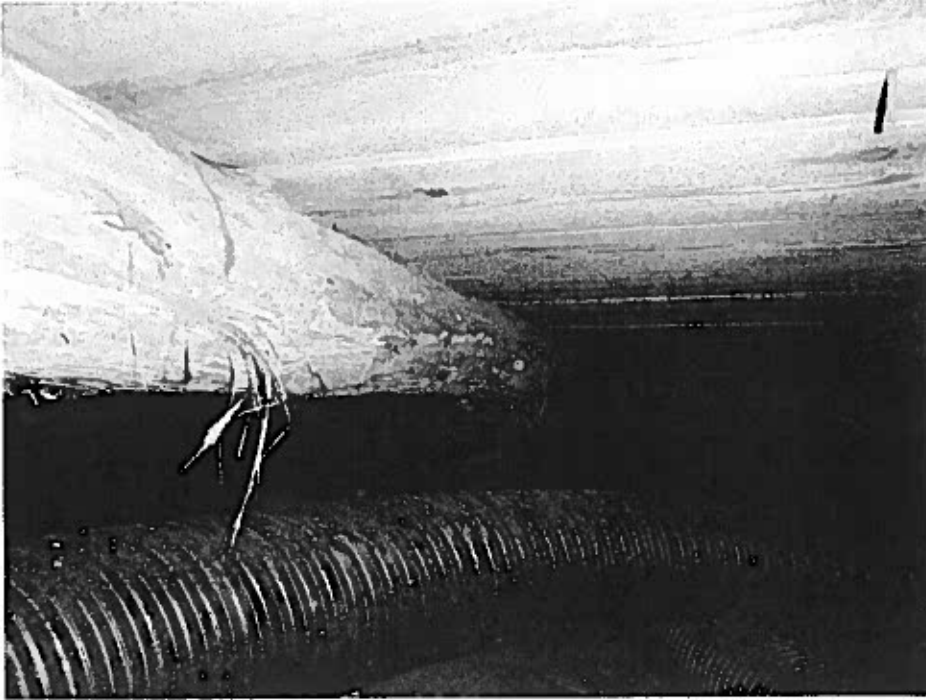
Looking west

Underside of flooring system at east end of building. Hand hewn floor joist, decking above. Beam and pier in background. Heating duct in foreground has been temporarily removed.

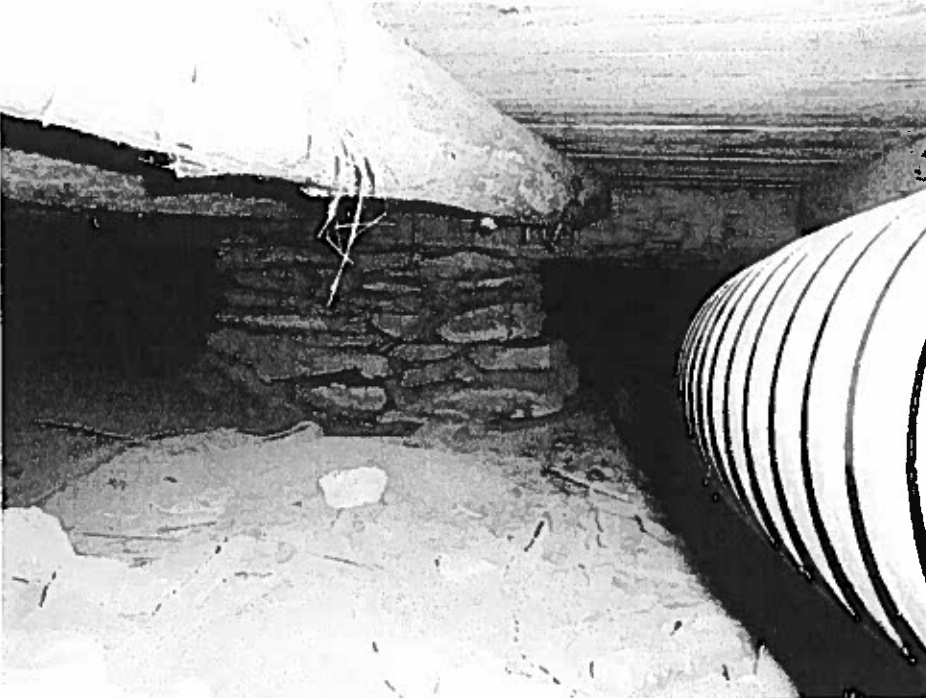
Looking west

Underside of flooring and support pier at east end. Pier is at approximate mid-span of beam.

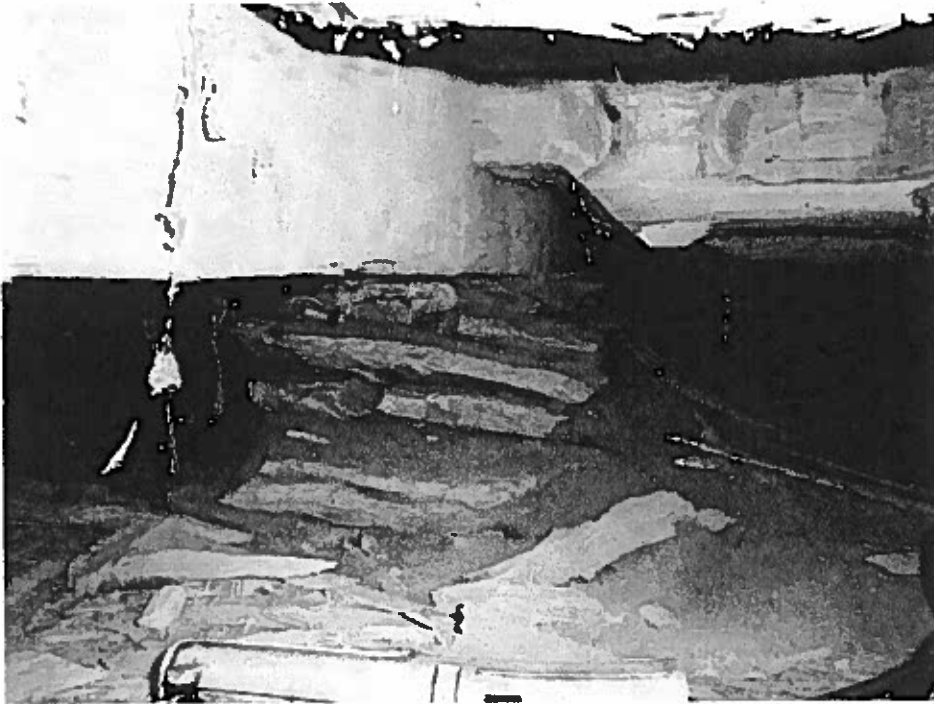
Looking south

The pier under the west beam is considerably more compromised than the one under the east beam. The field stones have moved horizontally and are not plumb and true. It is adjacent to this pier that the noticeable deflection is observed when the floor above is subject to live loading.

Underside of flooring system and west pier. Pier is under center of west beam.

It is virtually impossible to determine or even try to predict the structural properties of wooden members that are as old as the ones supporting this building. Section modulus data is not readily available or accurate. It is obvious that the support piers, especially the one under the west beam, need to be reinforced, as do at least some of the floor joists. This could become a significant undertaking, but would be necessary if any additional loading of the floor or expansion of the building were to be proposed.

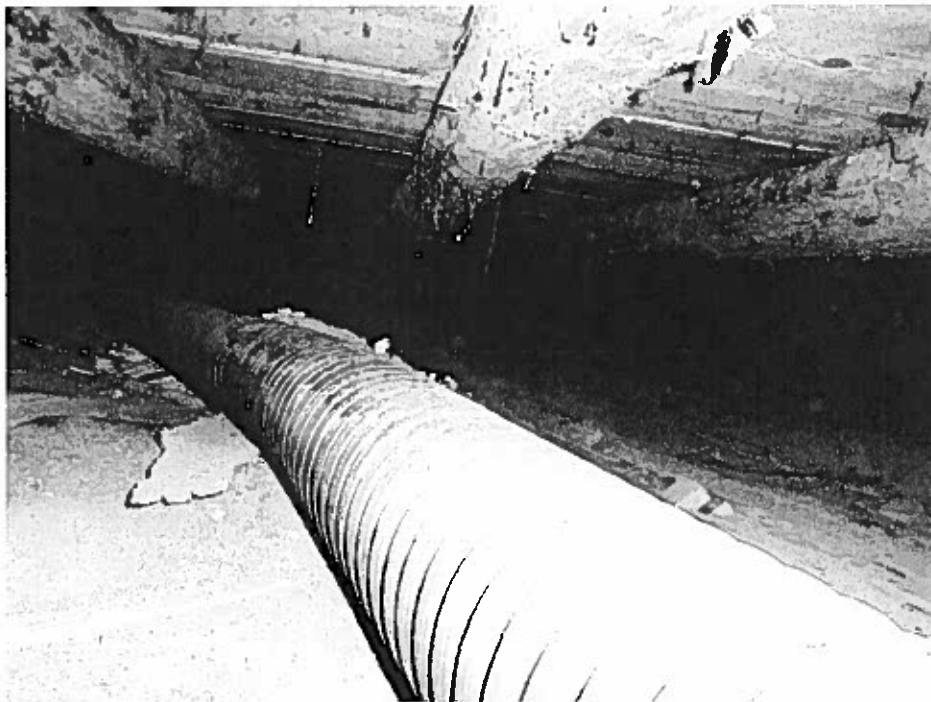
Looking east

Underside of flooring system at west end of building. Heating duct is in foreground.

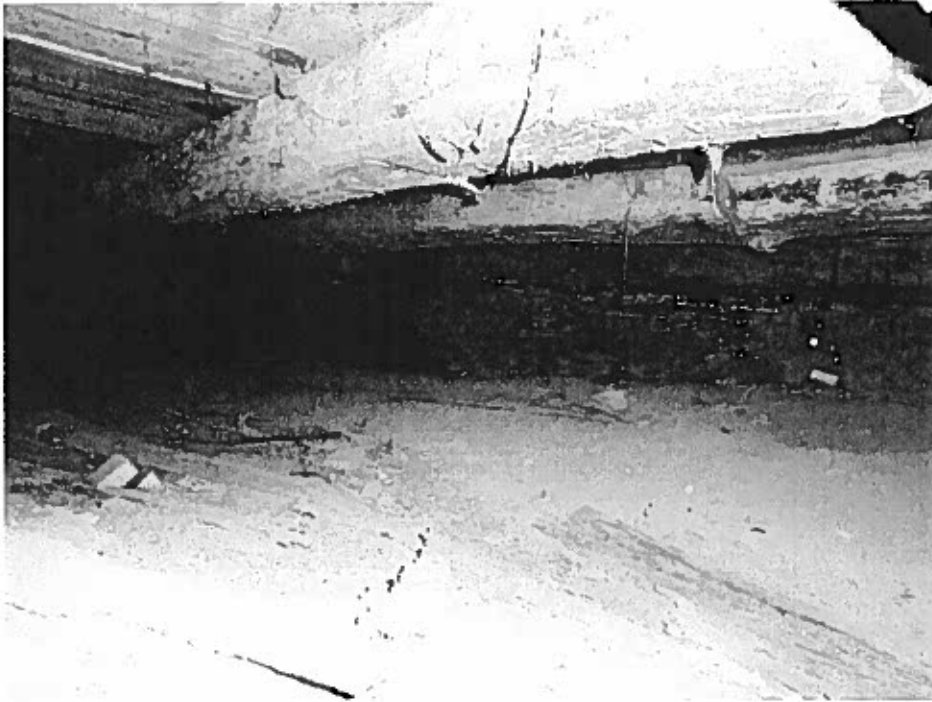
Looking southeast.

Underside of flooring system at west end. Note delamination of floor joist members.

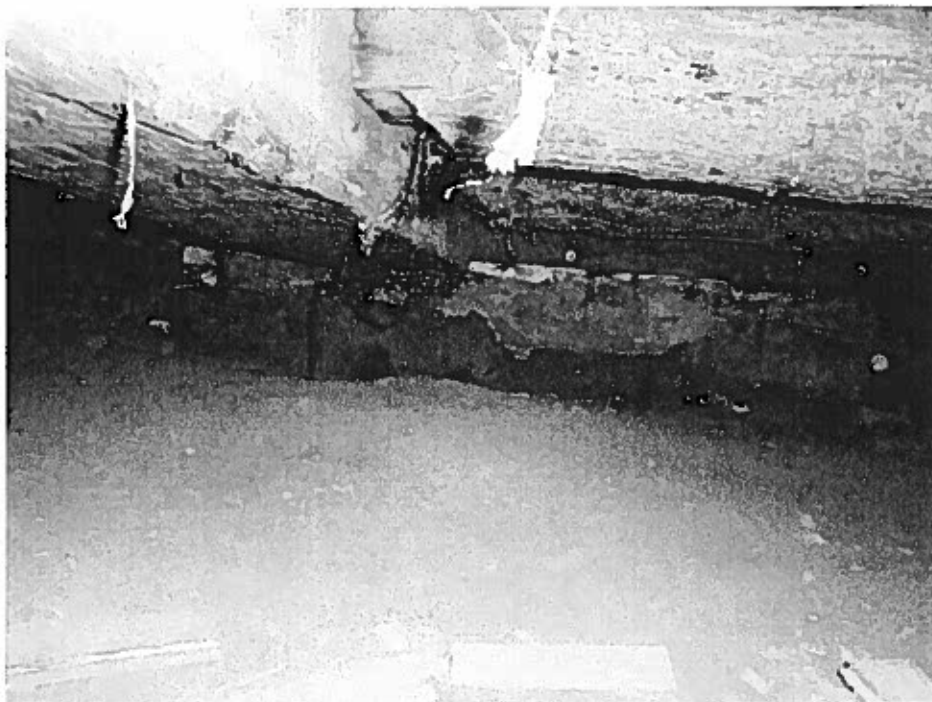
Looking south.

Underside of flooring system at west end. Hand hewn floor joists, decking above. South side of west beam, south foundation wall beyond.

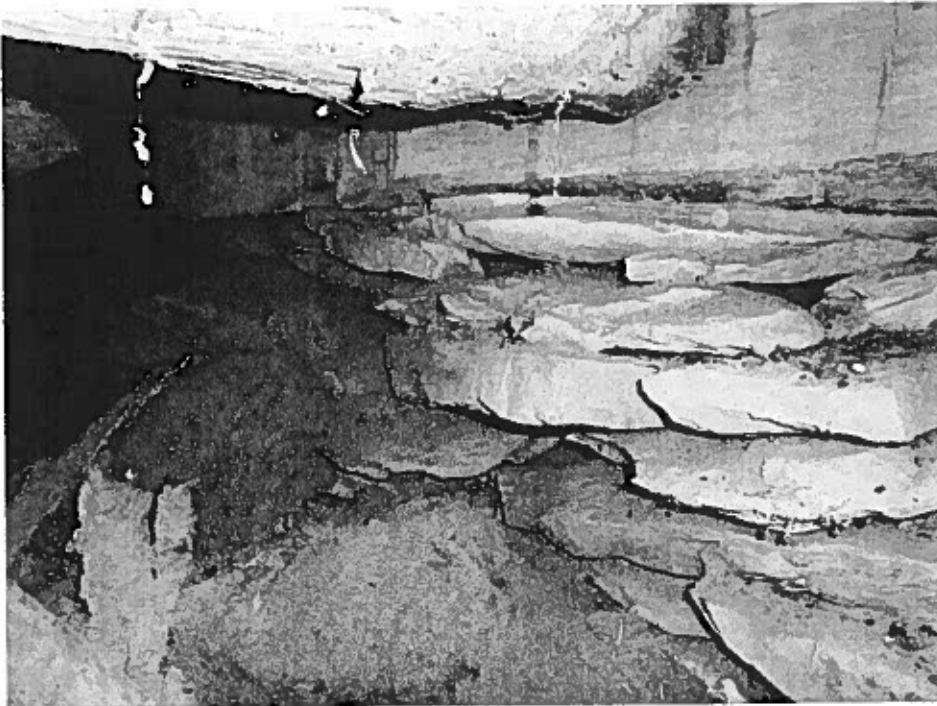
Looking northeast

Underside of flooring system; west pier at center of west beam. Note differential settlement of field stones.

Underside of flooring system at west pier supporting west beam.

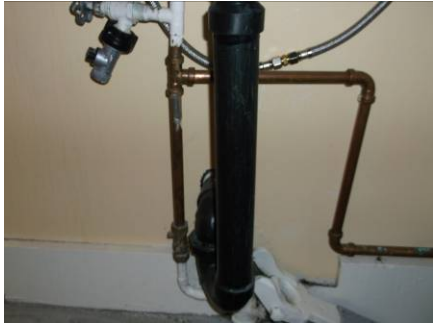
Located within the slab, the sanitary system is routed to the bathroom plumbing fixtures. Vertical piping from the plumbing fixtures appeared to be pvc piping. The piping appeared to be in good condition with no signs of leakage.

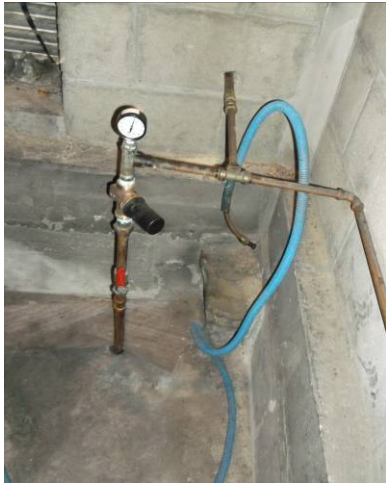
Domestic cold water piping enters the mechanical room from the slab and is routed to the exterior hose bib, toilet and bathroom sink. The piping is not insulated and runs exposed in the bathroom to shut off valves. The piping appeared to be in good condition with no signs of deterioration/leakage.

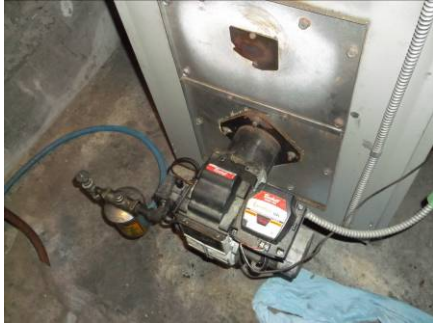
Space heating is provided by an oil fired furnace located in the mechanical room. The furnace is an model LB160 manufactured by the Boyertown Company and provides 175,000 BTU/hr of heating. Located outside the unit is an oil burner manufactured by the Carlin Company. The unit appeared to be over ten (10) years old and in good condition.

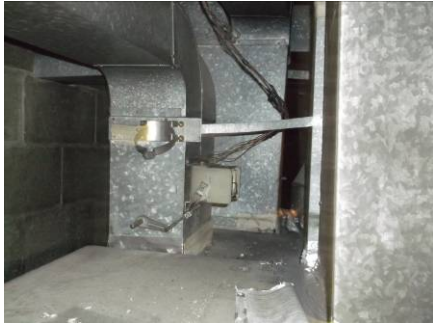
Metallic distribution ductwork from the furnace is routed to the first and second floors. The supply and return ductwork mains off the furnace is rectangular duct that transitions to round when exposed. Zone dampers were observed on the supply mains. The ductwork is not insulated and appeared to be in good condition. No records or evidence of duct cleaning was observed during our site visit.

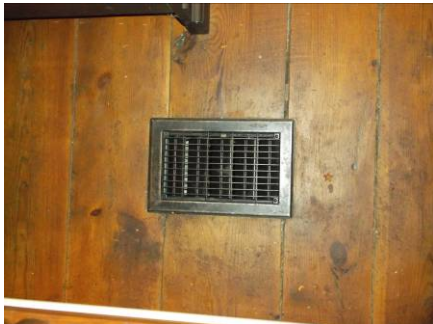
Air distribution within the space is provided through floor/wall mounted supply grilles. Sidewall grilles were observed on the first floor and floor grilles were observed on the second floor. The grilles appeared constructed of aluminum and appeared to be in good condition.

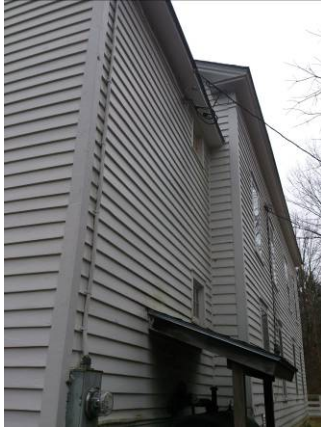
The electrical service entrance for the Egremont Academy Free Library is located on the north side of the building. The service wires are routed overhead from a pole located on Button Ball Lane. The wires are connected to the service entrance conductors at the second story level just under the eave. A service entrance (SE) cable, utilizing aluminum conductors, has been used for connection from the utility company service drop to the meter located on the Northeast corner of the building. The SE cable then runs from the meter into the building behind the above ground fuel tank and into the electrical panel.

This is in violation of the current Massachusetts Electrical Code (MEC) and local utility company, which require the service entrance cable to be protected from physical damage and installed in conduit. The existing wiring should be removed and replaced with wiring installed in conduit and weather head installed per MEC and local utility company requirements.

Replace existing service entrance cable with new service conductors routed in conduit.

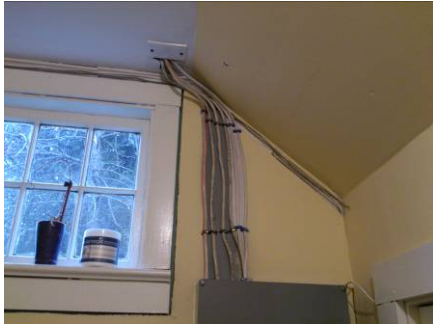
Branch circuit wiring consisted of nonmetallic-sheathed cable. The cabling was observed to be surfaced mounted in some areas or installed behind walls and/or above ceilings in others. The cabling was also installed in surface mounted raceway (wiremold) throughout the building as well.

It would appear as the wiring for the building had been updated in the past. The existing wiring seems to have been in place for 25 plus years and is in good condition for its age.

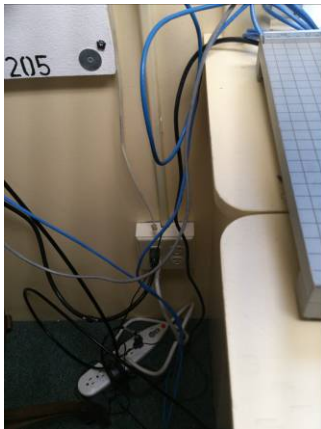
The receptacles within the building are type NEMA 5 duplex receptacles. A vast majority of the receptacles are surface mounted with a few being recessed mounted in the walls. A GFCI receptacle is located within the bathroom as required by code. However no receptacles were observed within the mechanical room.

GFCI receptacles should be added to mechanical room as well as an exterior weatherproof receptacle located near the proposed mechanical condensing unit to comply with current code.

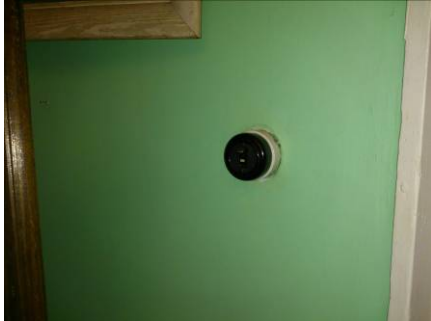
Very few switches were observed within the building. The few that are present are primarily surface mounted. The switches controlled only a few light fixtures. A large majority of light fixtures are controlled via pull chain. No three way switches were observed. The switches appeared to be in fair condition with the exception of one which is antiquated. Additional single pole and three way switches and associated wiring/conduit should be installed so that lighting can be switched from all entry/exit points of the rooms and stairways and allow for the elimination of pull chain and push button switches on the light fixtures themselves.

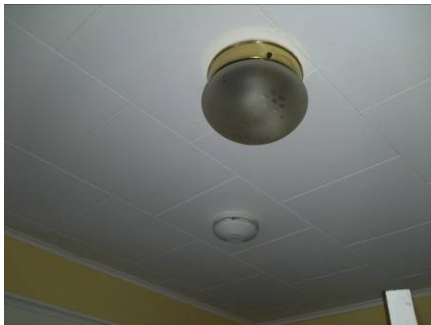
Lighting within the building consisted of a combination of different types of lighting. The types of lighting included a surface mounted incandescent fixture in the front entry vestibule, surface mounted 1' x 4' and recessed 2' x 4' fluorescent fixtures in the main floor library areas, an incandescent chandelier and porcelain socket in the side entry vestibule.

Replace existing light fixtures with energy efficient fixtures.

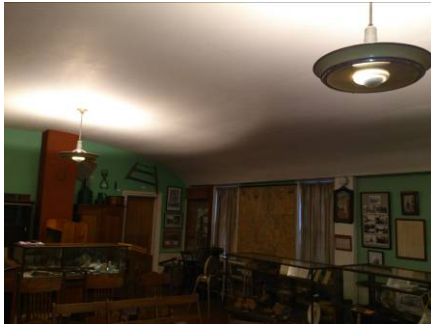
Lighting on the second floor consisted of two pendant mounted incandescent fixtures in the museum room and 1' x 4' surface mounted fluorescent fixtures in the office. Ceiling mounted porcelain socket with pull change and incandescent lamp was located in side room leading to attic access hatchway.

No lighting was observed in the attic area as is required by current code.

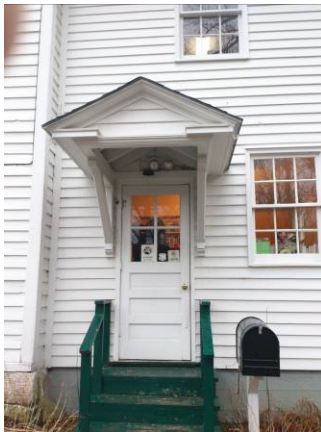
Exterior lighting was limited to a wall sconce adjacent to the front entry door and a flood light over the side entry door controlled by a motion sensor.

Existing light fixtures are inefficient, antiquated and of varying types. All lighting should be removed and replaced with new energy efficient fixtures.

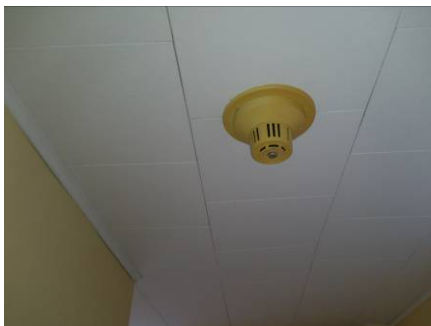
Detection devices consisted of two smoke detectors. One located at the top of each stairway and a single heat detector located in each room except for the second floor museum which has two wall mounted heat detectors installed. No detection devices were observed in the attic spaces. The detection devices appear to have been in place a number of years.

The existing fire alarm system should be removed and replaced with a fully addressable system. Smoke detection devices should be installed throughout with heat detectors installed in the attic spaces and mechanical room. Pull stations should be installed within five feet of the exit doors and at the proper height. Combination horn / Strobe notification devices should be installed were required by code.

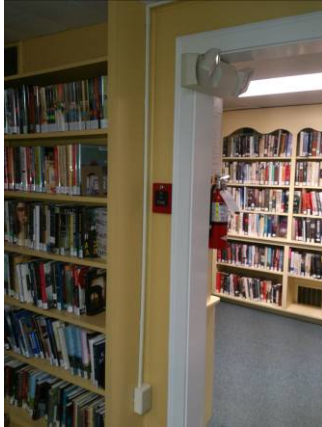
Initiation devices consisted of a single pull station located in between the two main library areas on the first floor. This device is mounted higher than allowed by current fire alarm code. Current fire alarm code also requires manual pull stations to be located within five feet of each exit door of the building.

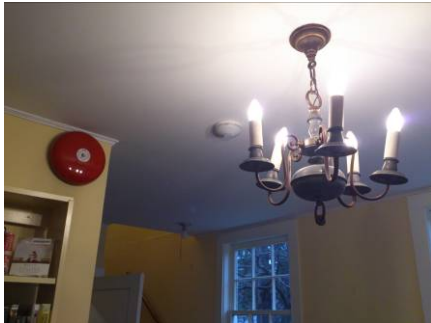
The only notification device observed within the building consisted of a fire alarm bell.

A fire department knox box was located on the exterior of the building adjacent to the main entry door.

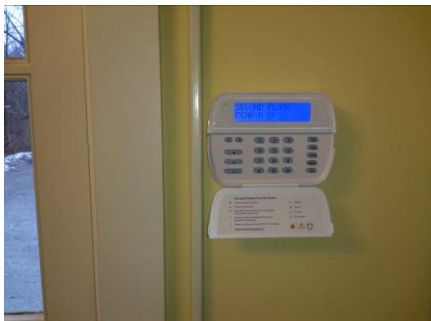
Security systems for the building consisted of a wireless system manufactured by DSC. The system utilizes door contact alarms and motion detectors. Door contacts are installed at both the main and side entry doors as well as the office doors on the second floor. Motion sensors were located

in the main entry vestibule, side entry room and first floor library area.

The keypad is located adjacent to the side entry door. Control panel and siren are located in the library on each side of the doorway from the side entry room.

The security system and entry/exit system appeared to be in good condition. Consideration should be given to the installation of additional motion detection and glass break sensors.

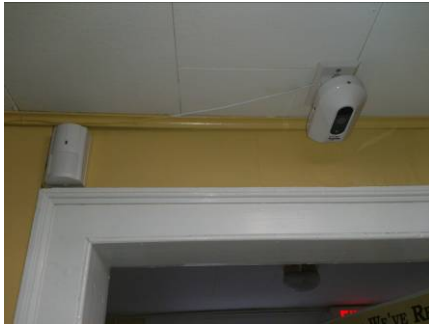
Also observed was a entry/exit chime system. The sensor unit was located above the door leading from the main entry into the library. A counter unit was located adjacent to the desk area in the front corner of the building. The sensor unit seems to also contain a video camera, however it does not appear as the wiring for viewing the camera has been installed.

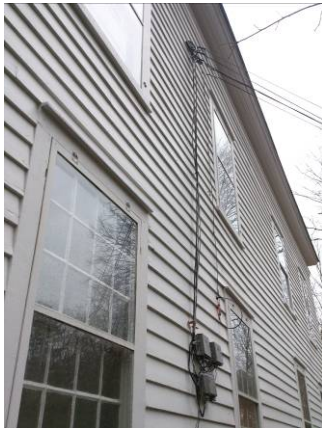
The building contained two different telecommunications systems. It appears as standard telephone wiring is routed over head from a utility pole on Button Ball Lane and down the north side of the building to system network interface boxes. It seems as this service is for the telephone system for the building only with the wiring extending from the system network interface boxes to telephone jacks located within the building. Two jacks were located adjacent to the FACP for the two phone line required by code. Jacks were also observed near the desk areas on the first floor and on the second floor mounted in front of the stage.

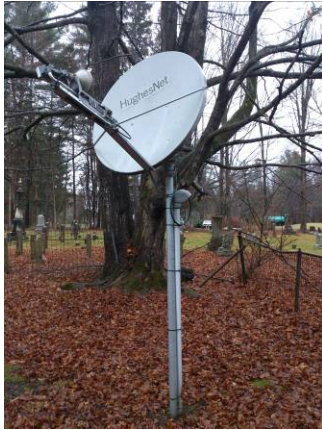
The second telecommunications system observed is a satellite based broadband high speed internet system. A satellite dish is located in the lawn area on the east side of the building facing southwest. Wiring is routed underground from the satellite dish to the building. Once at the building, the wiring is routed on the side of the building, enters through the mechanical room louver vent. It then runs through the mechanical room and above the library ceiling to the broadband equipment located on the south side of the building.
